NASA CR-179648
GARRETT 21-6355

THERMAL BARRIER COATING LIFE-PREDICTION MODEL DEVELOPMENT FINAL REPORT

**GARRETT TURBINE ENGINE COMPANY
A DIVISION OF THE GARRETT CORPORATION
PHOENIX, ARIZONA**

**NATIONAL AERONAUTICS AND SPACE ADMINISTRATION
NASA-LERC (CONTRACT NAS3-23945)**

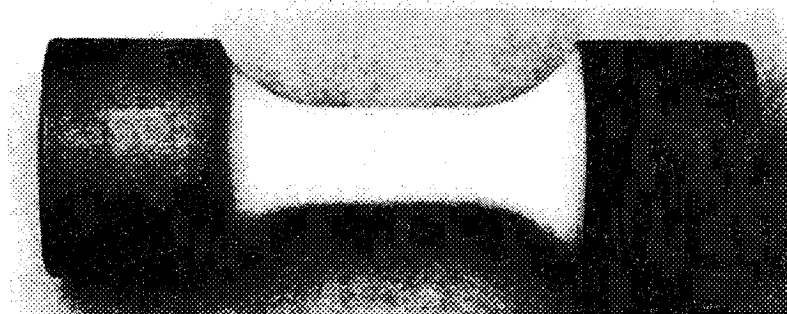
Figure 13. Solid Mar-M 247 TBC Coated Samples Were Used to Obtain the Spalling Strain Data for the Chromalloy and Temescal TBC Systems.

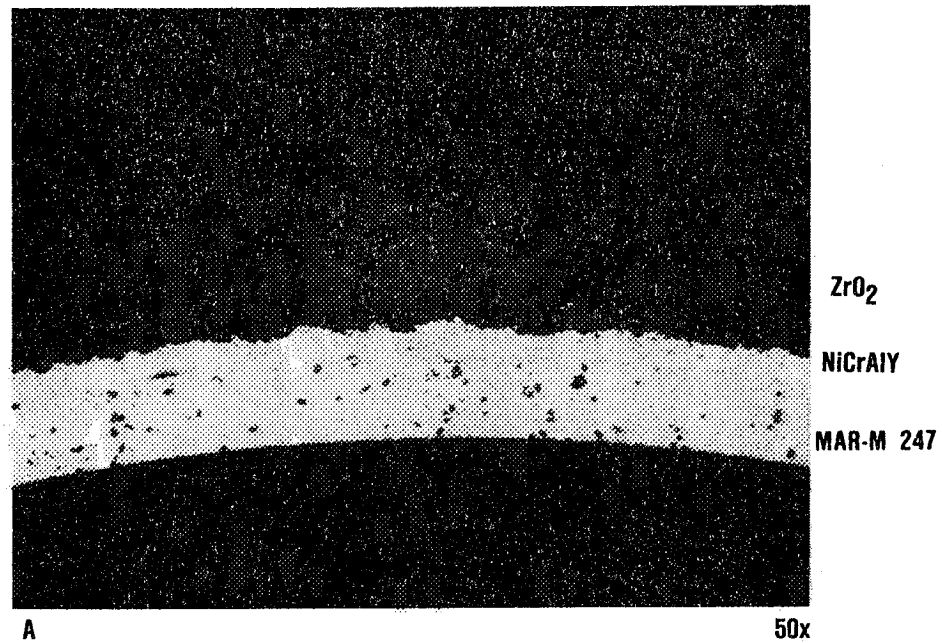
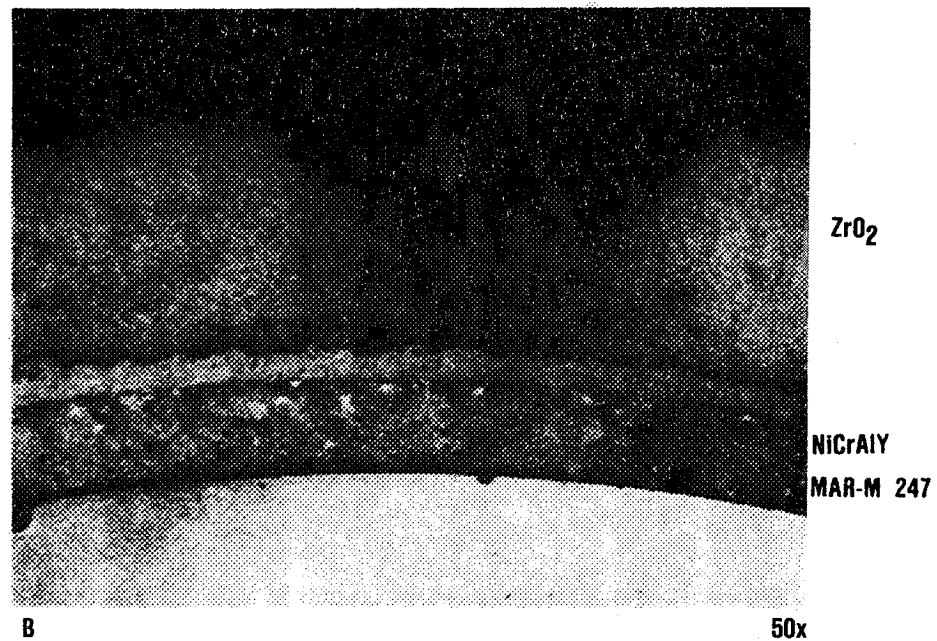
Figure 25. The Degree of Interconnected Microcracks and Porosity is Shown By Ink Wicking into the ZrO_2 Coating: (a) Regular Lighting (b) Polarized Light.

Microstructures of the plasma-sprayed zirconia coating contained interconnected microporosity and microcracking, which are responsible for the low moduli values. Ink drops placed on the surface of this thick TBC system wicked into the coating and penetrated to the zirconia/NiCrAlY interface (Figure 25).

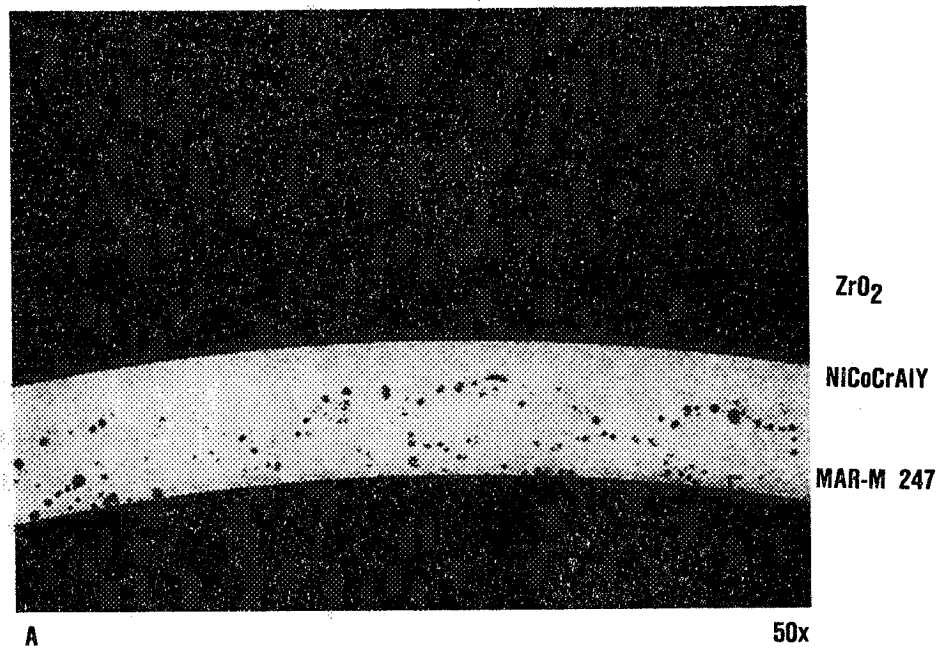
Figure 26. The Open Columnar Microstructure of the EB-PVD ZrO_2 Accounts for the Lower Young's Modulus: (a) Regular Lighting (b) Polarized Light.

The elastic moduli of the open columnar microstructure of the EB-PVD ZrO_2 are approximately half of the plasma-sprayed ZrO_2 . Low values are attributed to the columnar microstructure of the EB-PVD coating. The open columnar microstructure is shown in Figure 26, where ink wicked into the columnar microstructure and penetrated down to the $\text{ZrO}_2/\text{NiCoCrAlY}$ interface.
